Old Oakland Road Habitat Mitigation Project
Story Road Mitigation Site #2

Year 5 (2009) Monitoring Report

**OLD OAKLAND ROAD HABITAT MITIGATION PROJECT
STORY ROAD MITIGATION SITE No. 2**

YEAR 5 (2009)

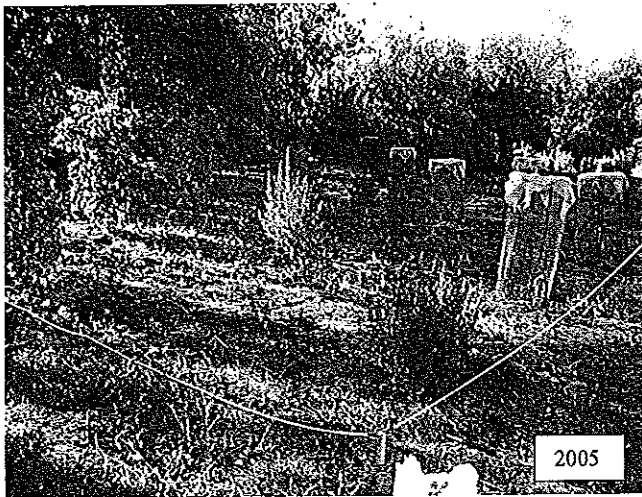
Figure 7A. View of Sample Plot 1, October 2005. Sample plot contains 7 plants; 3 coyote brush, 1 blackberry and 2 box elders. One empty planting area was noted. Herbaceous/bare cover is 80%; shrub cover is 10% and tree cover is 10%.

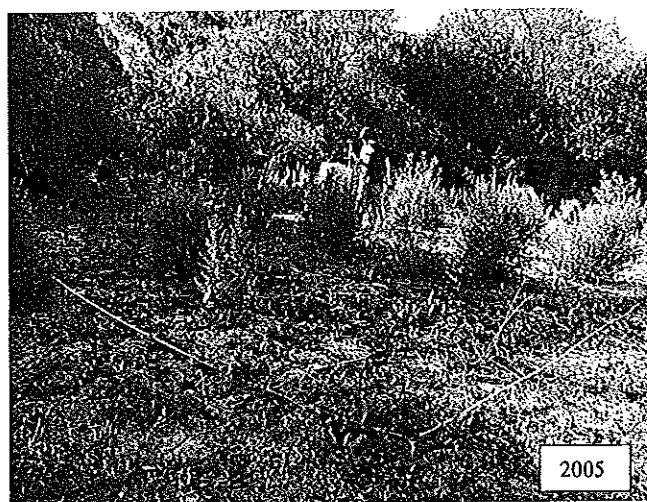
Figure 8A. View of Sample Plot 2, October 2005. Sample plot contains 14 plants consisting of 7 blackberries and 7 coyote brush. Herbaceous/bare cover is 60%; shrub cover is 40% and tree cover is 0%.

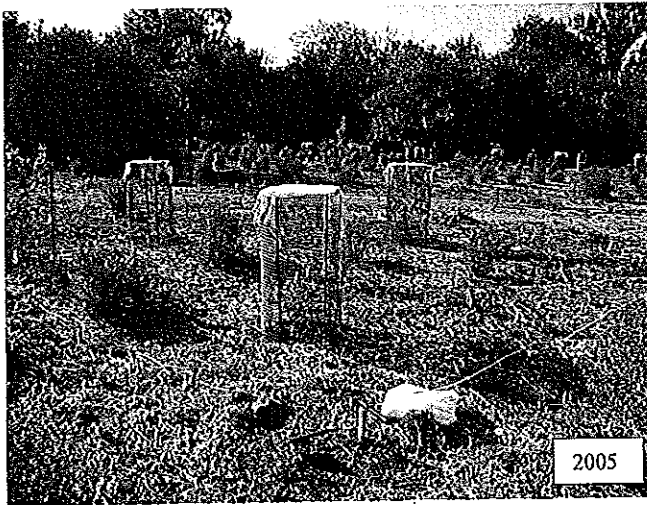
Figure 9A. View of Sample Plot 3, October 2005. Sample plot contains 10 plantings, consisting of 4 coyote brush, 2 coast live oaks, 3 blackberries and 1 sycamore. Herbaceous/bare cover is 79%; shrub cover is 20% and tree cover is 1%.

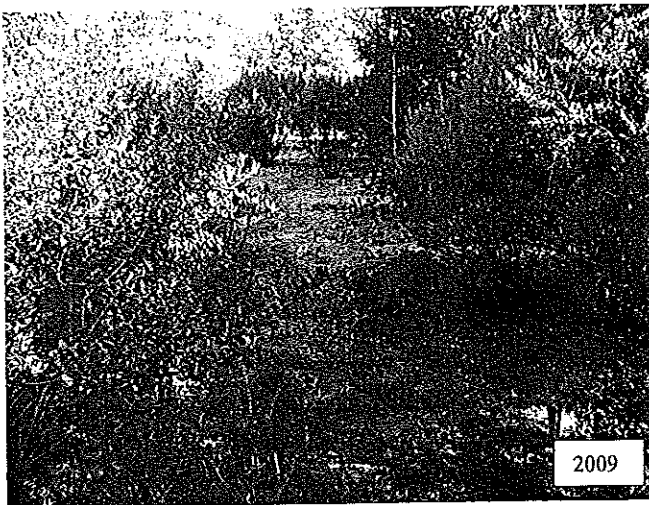
Figure 9B. View of Sample Plot 3, August 2009. Herbaceous/bare cover is 10%; shrub cover is 80% and tree cover is 10%. Natural recruitment of coyote brush.

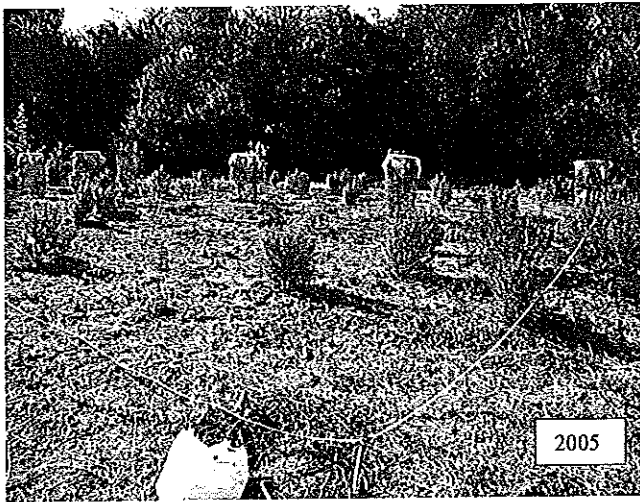
Figure 10A. View of Sample Plot 4, October 2005. Sample plot contains 7 plantings , consisting of 7 coyote brush. Herbaceous/bare cover is 60%; shrub cover is 40% and tree cover is 0%.

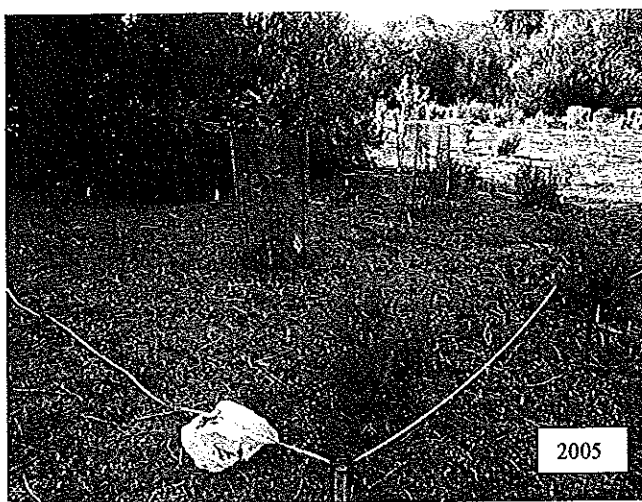
Figure 11A. View of Sample Plot 5, October 2005. Sample plot contains 5 plantings, consisting of 1 coyote brush, 1 blackberry, 1 coast live oak, 1 willow and 1 sycamore. Herbaceous/bare cover is 94%; shrub cover is 5% and tree cover is 1%.

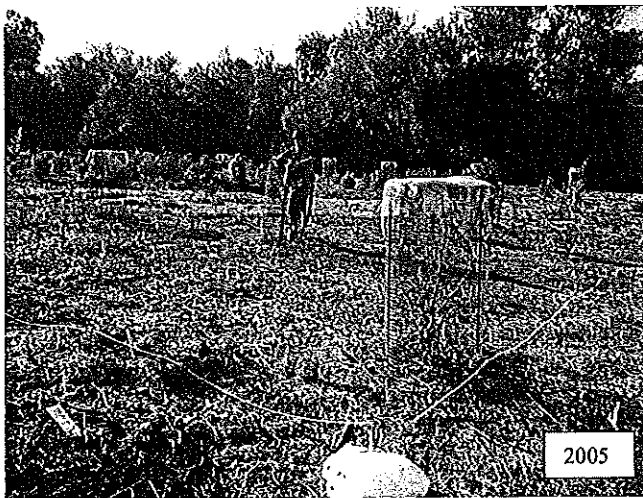
Figure 12A. View of Sample Plot 6, October 2005. Sample plot contains 10 plantings, consisting of 1 blackberry, 3 sycamore, 4 snowberry and 2 empty sites. Herbaceous/bare cover is 98%; shrub cover is 1% and tree cover is 1%.

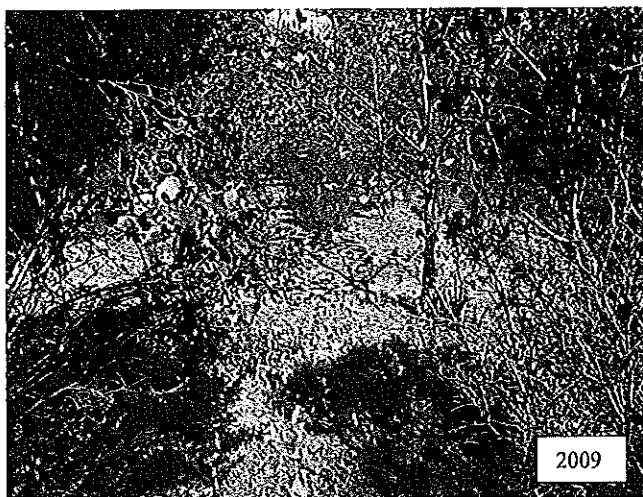
Figure 12B. View of Sample Plot 6, August 2009. Herbaceous/bare cover is 40%; shrub cover is 10% and tree cover is 50%. Natural recruitment by snowberry.

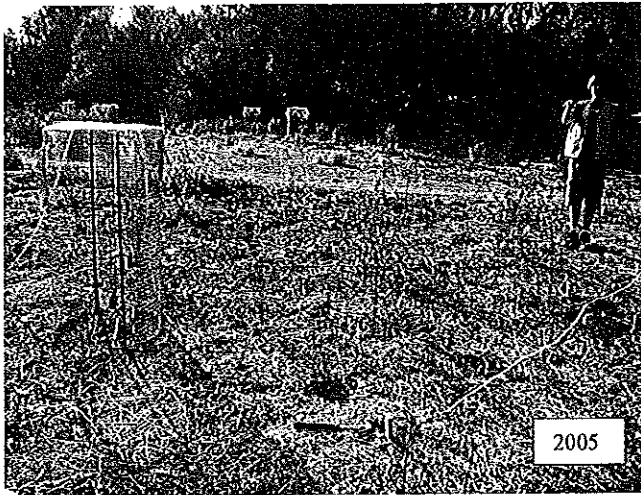
Figure 13A. View of Sample Plot 7, October 2005. Sample plot contains 9 plantings, consisting of 9 snowberries. Herbaceous/bare cover is 80%; shrub cover is 20% and tree cover is 0%.

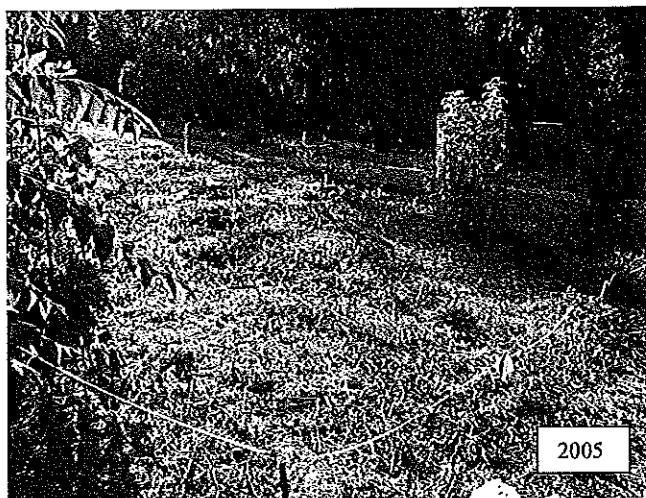
Figure 14A. View of Sample Plot 8, October 2005. Sample plot contains 5 plantings, consisting of 1 box elder, 3 snowberries and 1 sycamore. Herbaceous/bare cover is 94%; shrub cover is 1% and tree cover is 5%.

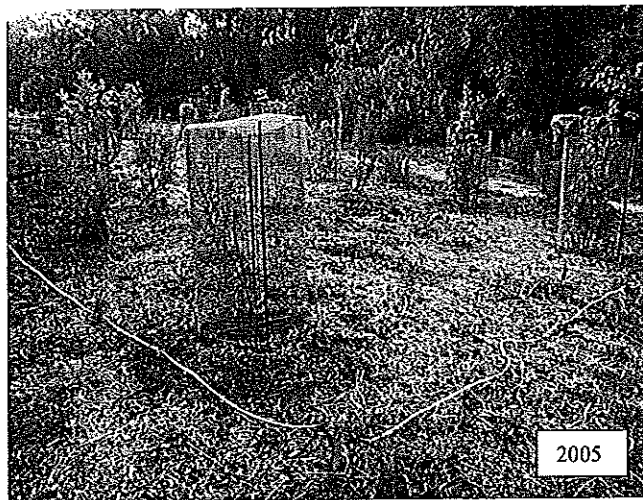
Figure 15A. View of Sample Plot 9, October 2005. Sample plot contains 10 plantings, consisting of 2 buckeyes, 2 blackberries, 1 box elder, 4 coyote brush and 1 empty site. Herbaceous/bare cover is 79%; shrub cover is 20% and tree cover is 1%.

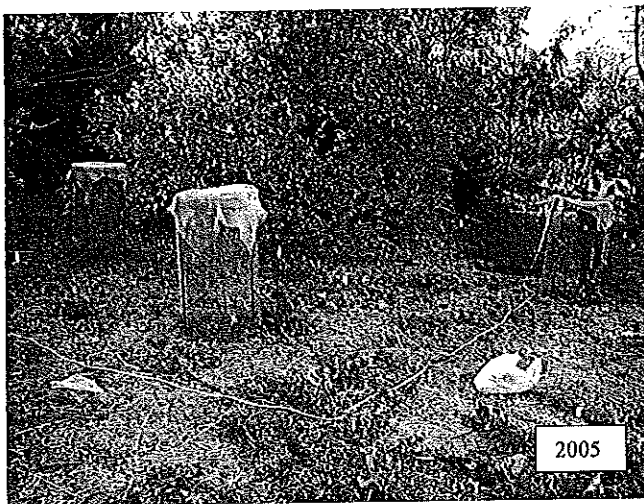
Figure 16A. View of Sample Plot 10, October 2005. Sample plot contains 11 plantings, consisting of 5 snowberry, 1 coyote brush, 1 blue elderberry, 1 buckeye and 3 empty sites. Herbaceous/bare cover is 90%; shrub cover is 5% and tree cover is 5%.

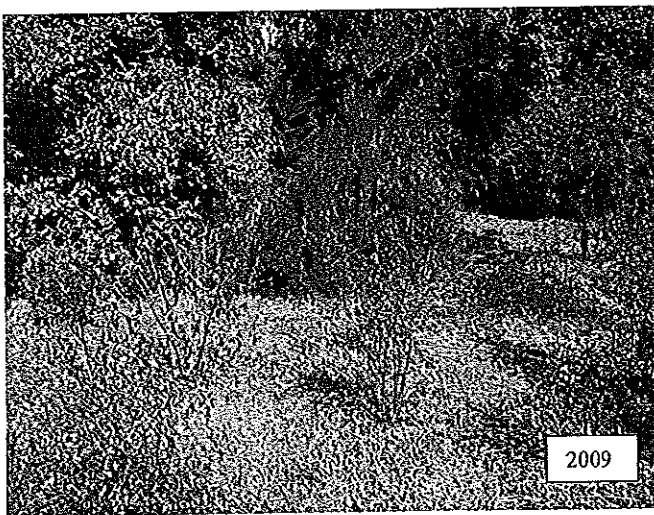
Figure 16B. View of Sample Plot 10, August 2009. Herbaceous/bare cover is 50%; shrub cover is 40% and tree cover is 10%.

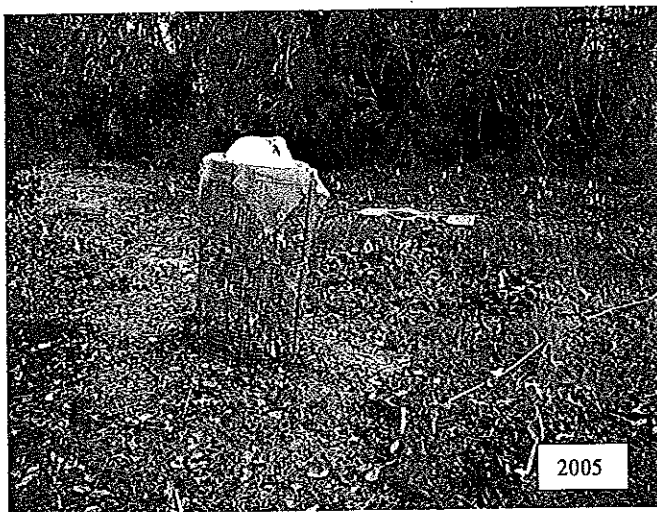
Figure 17A. View of Sample Plot 11, October 2005. Sample plot contains 8 plantings, consisting of 1 box elder, 6 snowberries and 1 empty site. Herbaceous/bare cover is 90%; shrub cover is 5%, tree cover is 5%.

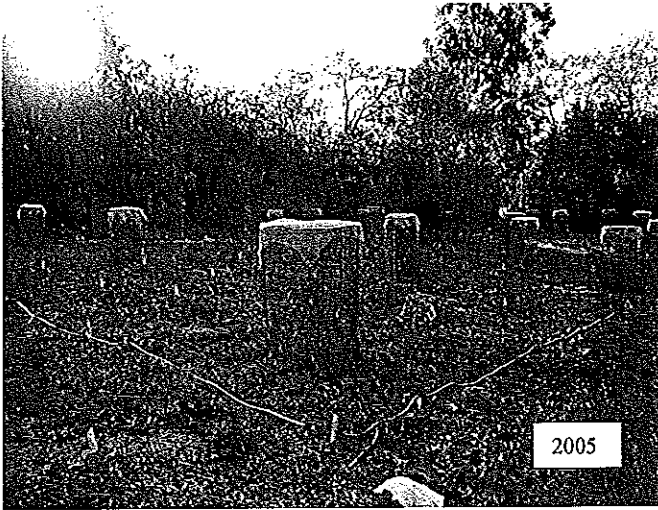
Figure 19A. View of Sample Plot 13, October 2005. Sample plot contains 10 plantings, consisting of 5 snowberries, 1 coast live oak, 1 blue elderberry, 1 box elder, 1 coyote brush and 1 empty site. Herbaceous/bare cover is 94%; shrub cover is 5%, tree cover is 1%.

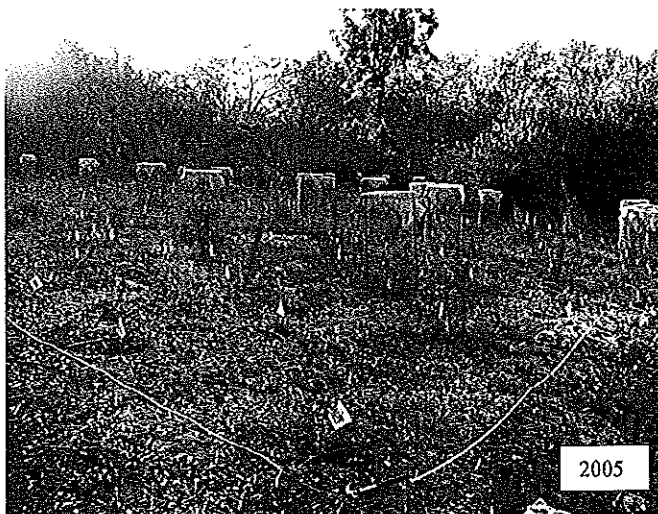
Figure 20A. View of Sample Plot 14, October 2005. Sample plot contains 10 plantings, consisting of 8 mugwort, 1 blue elderberry, and 1 empty site. Herbaceous/bare cover is 90%; shrub cover is 10%, tree cover is 0%.

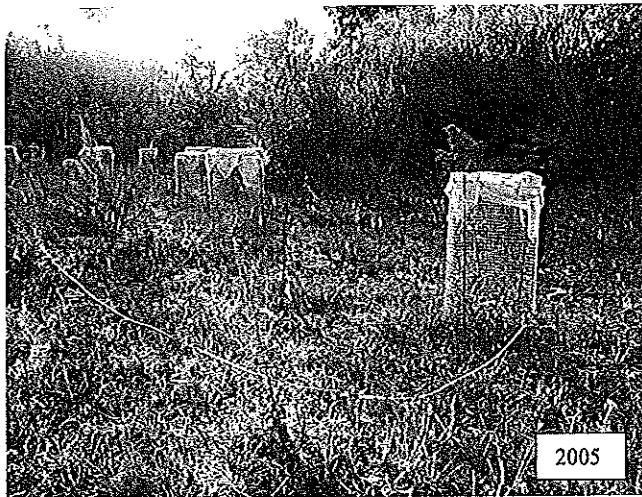
Figure 21A. View of Sample Plot 15, October 2005. Sample plot contains 8 plantings, consisting of 6 mugwort and 2 buckeyes. Herbaceous/bare cover is 60%; shrub cover is 39%, tree cover is 1%.

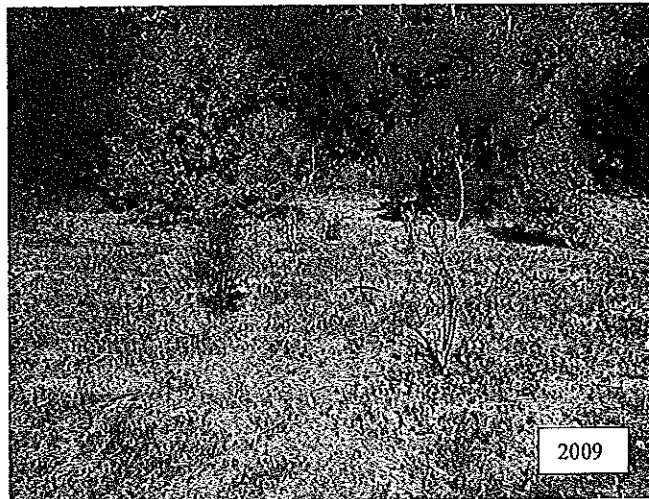
Figure 21B. View of Sample Plot 15, August 2009. Herbaceous/bare cover is 50%; shrub cover is 40%, tree cover is 10%.
